**Flood Control Project Maintenance****2013 Structure Summary Report****Overall Unit and Item Ratings****Lower San Joaquin Levee District****Ash Slough Drop Structure No. 1**

Overall Unit Rating	Rated Item	Item Rating
<b>A</b>	Photo Documentation	N
	Vegetation & Obstructions	A
	Shoaling / Sedimentation	A
	Erosion / Bank Caving	A
	Revetments	M
	Encroachments	A
	Culverts: Inlets / Outlets	N
	Culverts: Breaks / Holes / Cracks	N
	Metal Pipes	N
	Trash Racks	N
	Flap Gates	N
	Sluice/Slide Gates	N
	Electric Gate Operators	N
	Manual Gate Operators	N
	Concrete Surfaces	A
	Concrete Tilting / Settlement	A
	Concrete Foundations	A
	Security Fencing	N
	Closure Structures	N
	Trash Rakes	N
	Other Metallic Items	N
	Monolith Joints	A
	Safety	A
	Operation & Maintenance Manual	A

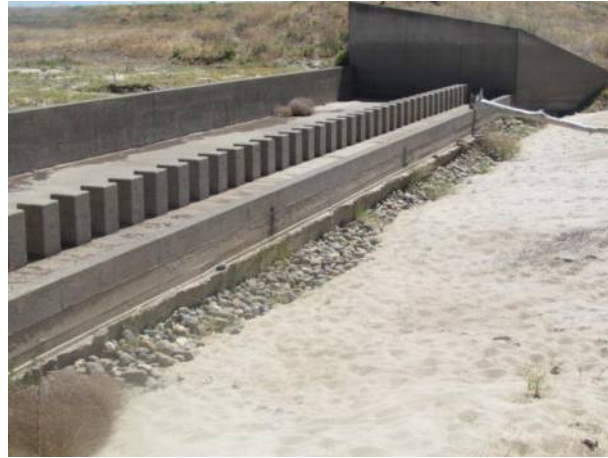
Levee Mile Report Line	5
Start Levee Mile	0.00
End Levee Mile	0.00
Location	
Category	Structures
Item	Revetments
Looking east at riprap displacement on downstream side of structure.	
richard_t_20130715_003.JPG

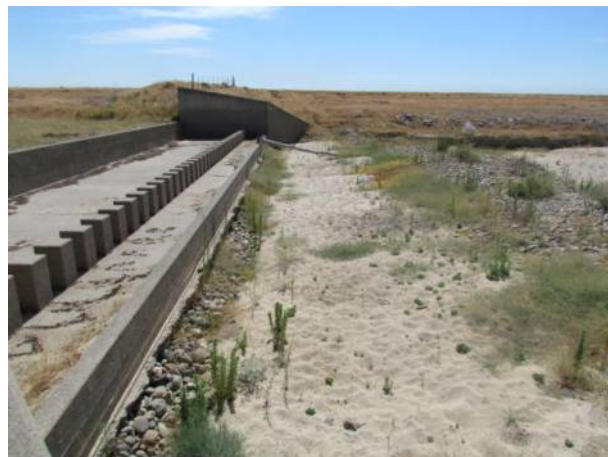
Levee Mile Report Line	5
Start Levee Mile	0.00
End Levee Mile	0.00
Location	
Category	Structures
Item	Revetments
Looking east at riprap displacement on downstream side of structure. (2013)	
Richard_t_20130730_142.JPG

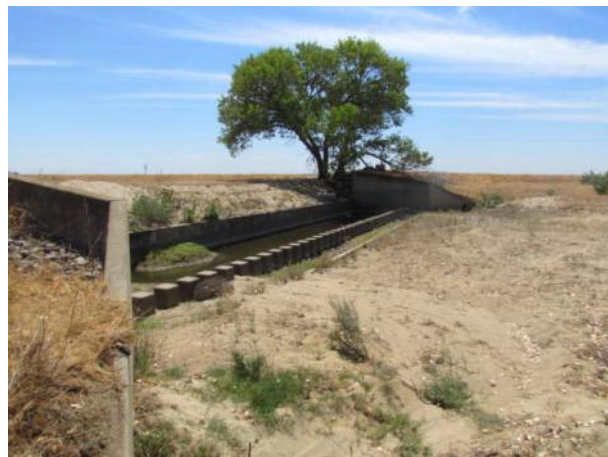
Levee Mile Report Line	6
Start Levee Mile	0.00
End Levee Mile	0.00
Location	
Category	Structures
Item	Encroachments
Looking east at dam across upstream side of structure. (2013)	
Richard_t_20130730_159.JPG

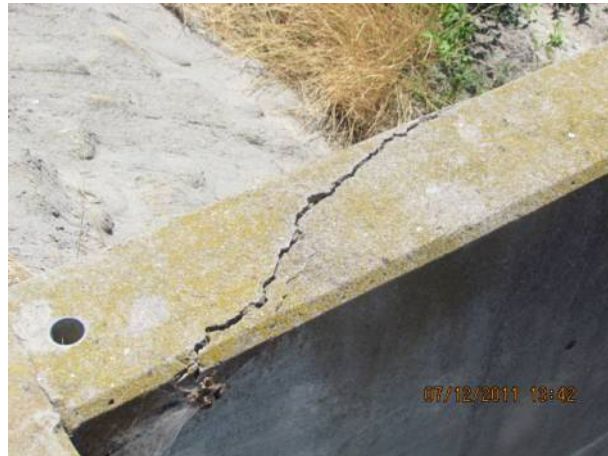
Levee Mile Report Line	15
Start Levee Mile	0.00
End Levee Mile	0.00
Location	
Category	Structures
Item	Concrete Surfaces
Looking at cracking on left wing wall.	
richard_t_20130715_023.jpg

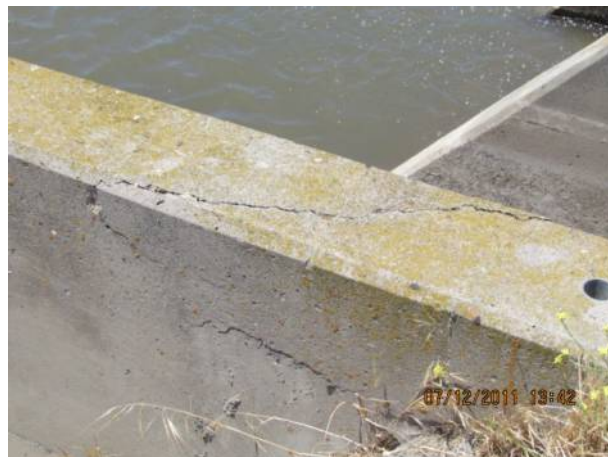
Levee Mile Report Line	15
Start Levee Mile	0.00
End Levee Mile	0.00
Location	
Category	Structures
Item	Concrete Surfaces
Looking northwest at cracking on left wing wall	
richard_t_20130715_024.jpg

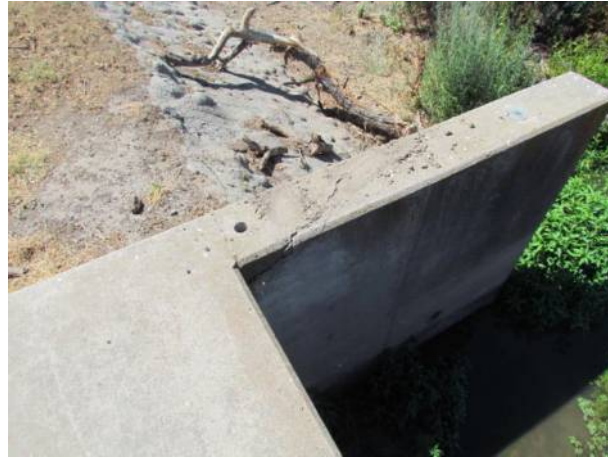
Levee Mile Report Line	15
Start Levee Mile	0.00
End Levee Mile	0.00
Location	
Category	Structures
Item	Concrete Surfaces
Looking at crack on left wing wall during 2012 inspection.	
richard_t_20130715_025.JPG

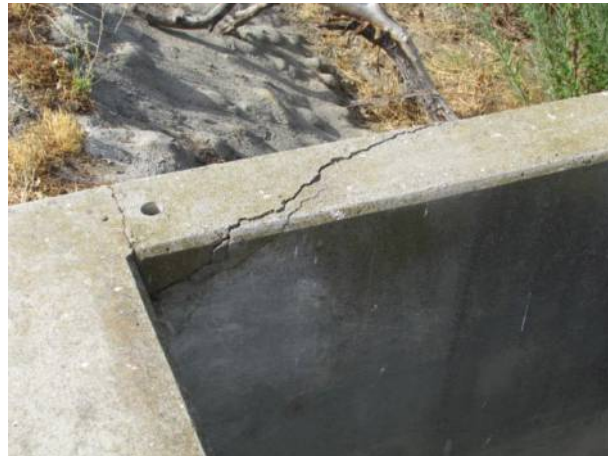
Levee Mile Report Line	15
Start Levee Mile	0.00
End Levee Mile	0.00
Location	
Category	Structures
Item	Concrete Surfaces
Looking at cracking on left wing wall Summer 2013	
richard_t_20130729_098.JPG

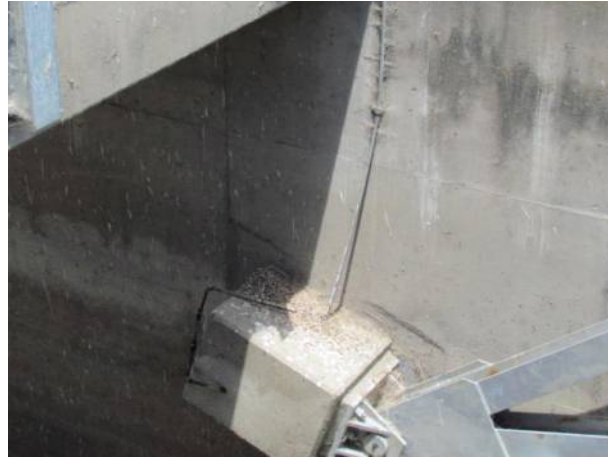
Levee Mile Report Line	12
Start Levee Mile	0.00
End Levee Mile	0.00
Location	
Category	Structures
Item	Sluice/Slide Gates
Looking at grease tube disconnected from hing point.	
richard_t_20130729_117.JPG

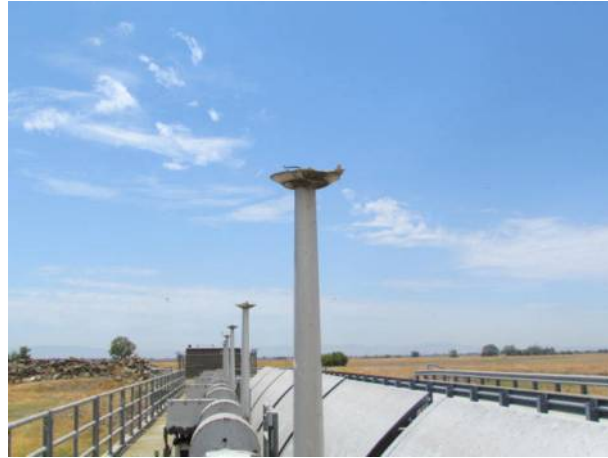
Levee Mile Report Line	23
Start Levee Mile	0.00
End Levee Mile	0.00
Location	
Category	Structures
Item	Safety
Looking at missing light fixtures near electric gate operators.	
richard_t_20130729_116.JPG

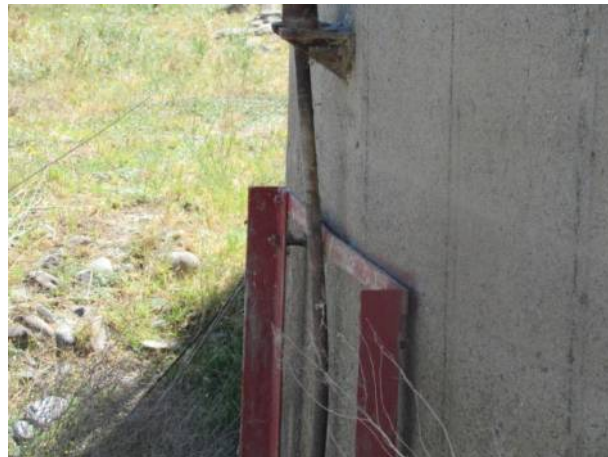
Looking east at minor crack on joint at top of structure on the downstream side of structure.

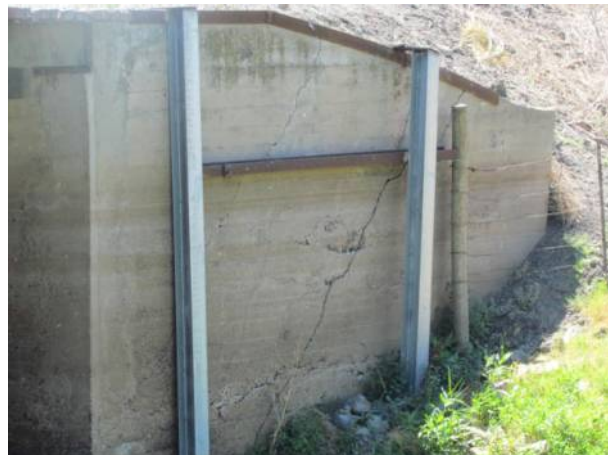
Levee Mile Report Line	16
Start Levee Mile	0.00
End Levee Mile	0.00
Location	
Category	Structures
Item	Concrete Tilting / Settlement
Looking at repaired right wing wall on downstream side of structure. Summer 2012	
richard_t_20130715_062.JPG
